# Stormwater Basin Retrofit

## Improving Stormwater Management within Existing Facilities

# Stormwater Basin Retrofit—A Case Study

## Sidley Road Basin, East Whiteland Township

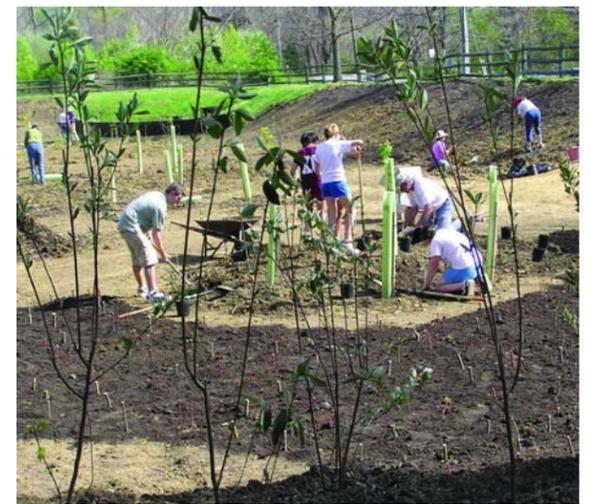
*The retrofit of this stormwater basin at Sidley Road included small berms to increase the length of flow to allow more pollutant removal, and planting over 400 trees and 300 live stakes in the 3/4 acre stormwater basin.*

The structural modifications to the basin included re-grading the basin to create a small berm and meanders, and modification to the outlet to hold back low flows, which maintain soil moisture for the vegetation, while still controlling the larger storms.

The re-grading of the basin provided a meandering flow path from the basin inlets to the outlet which allow for settling and filtering of sediments and pollutants within the vegetation. The construction work was completed by East Whiteland Township Public Works Department under the direction of Cahill Associates.

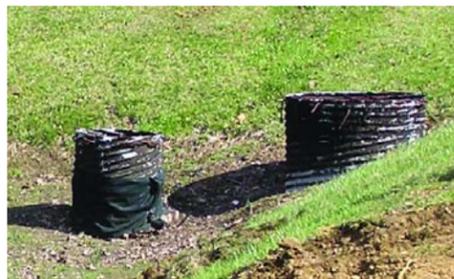
The modification to the outlet included covering the lowest opening with a geotextile and soil to create a shallow pool of water immediately after storm events.

The modification to the outlet included covering the lowest opening in the standpipe with geotextile, and soil. The outlet structure of the Sidley Road basin includes two stand pipe outlets, one 30-inch in diameter and a larger pipe, 48-inches in diameter. The purpose of the outlet modification was to maintain the existing peak flow control for large storms while providing a small pool of water following rain-fall events to provide the necessary soil moisture for the selected plants, and allow evapotranspiration.

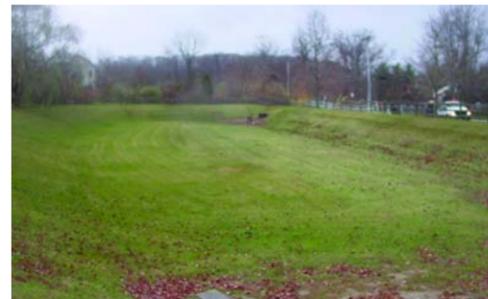
The basin at Sidley Road in East Whiteland Township prior to the retrofit.

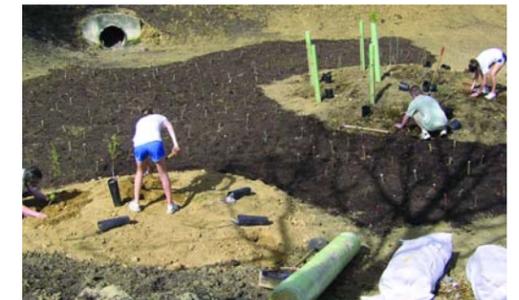
Students from the Ecology Club of Great Valley High School planting trees and shrubs near the live stakes close to the inlet of the basin.

The planting of the basin took place over four workdays in April 2006. Approximately 419 bushes and trees, and 300 live stakes were planted. There were nineteen types of trees and shrubs planted, and the live stakes were equal numbers of silky and red osier dogwoods. Live stakes are cuttings of plants that will take root.

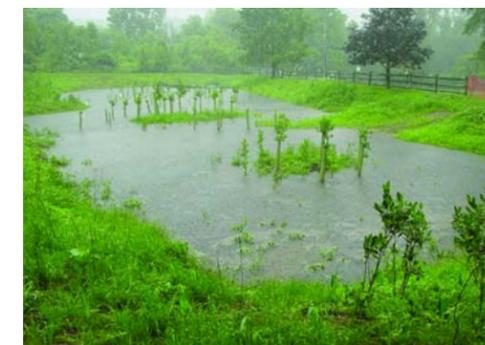
The basin operated as designed during this storm event on June 26, 2006. The created berms are evident as the basin fills.

The change in floor contours and flow direction has been successful and the modification to the basin outlet to allow a small ponding has performed as designed.
